Bureau of Mines Information Circular/1986

Ground Subsidence and Structural Damage Over an Abandoned Room-and-Pillar Coal Mine at Hegeler, IL

By Gennaro G. Marino, James W. Mahar, Larry R. Powell,
and Richard E. Thill

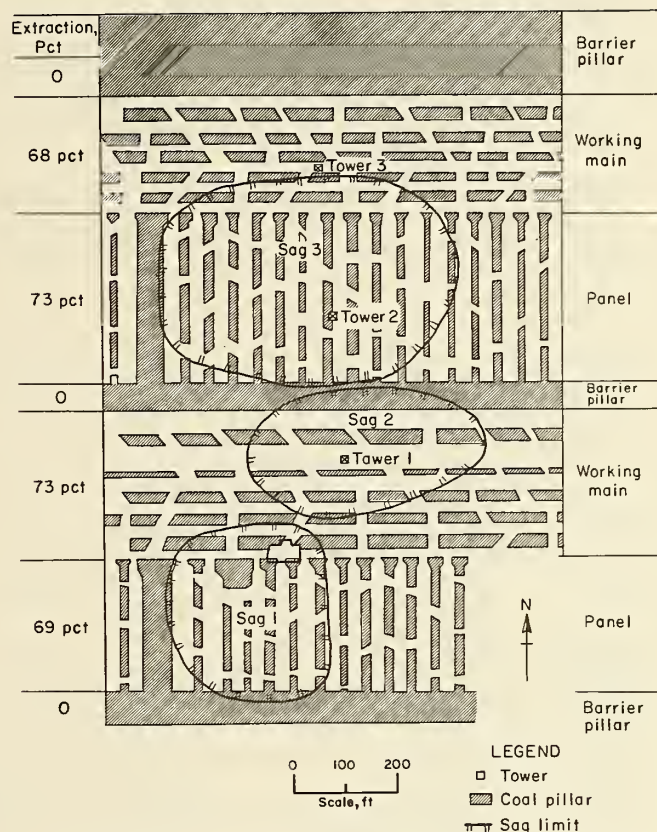
FIGURE 4. - Mine map showing location of subsidence sags.

Sag 2 develop in the field north of the radio station building in May or June 1968. The center of the sag is located 40 ft northwest of tower 1. Most of the settlement (3 ft) occurred rapidly within 6 weeks. Tower 1 subsided 2.75 ft, which caused the guy wires supporting the tower to loosen, and they had to be retightened several times. Surface water collected in the sag around tower 1.

In November or December 1976, sag 3 developed under tower 2. The tower nearly failed when it settled and tilted 0.05 ft

to the east. In July 1978, residual subsidence of sag 3 produced settlement and lateral movement of the southwest guy wire anchors for tower 3. The upper 150 ft of the tower was bent in response to the ground movements. The maximum settlement was about 3 ft.

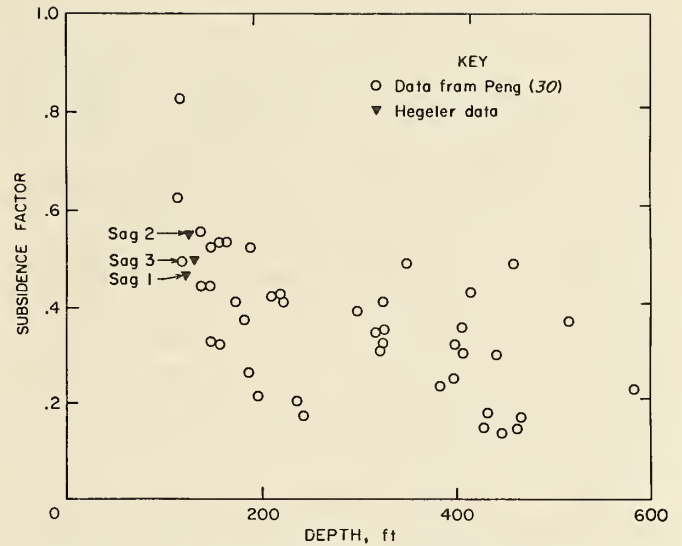
FIGURE 12. - Relationship between mine depth and the subsidence factor.

In figure 12, the subsidence factor is plotted against mine depth for subsidence cases over Illinois room-and-pillar mines. The Hegeler subsidence sags are comparable with other subsidence sags at similar mining depths in Illinois. The general trend of the plot shows decreasing subsidence with increasing depth.

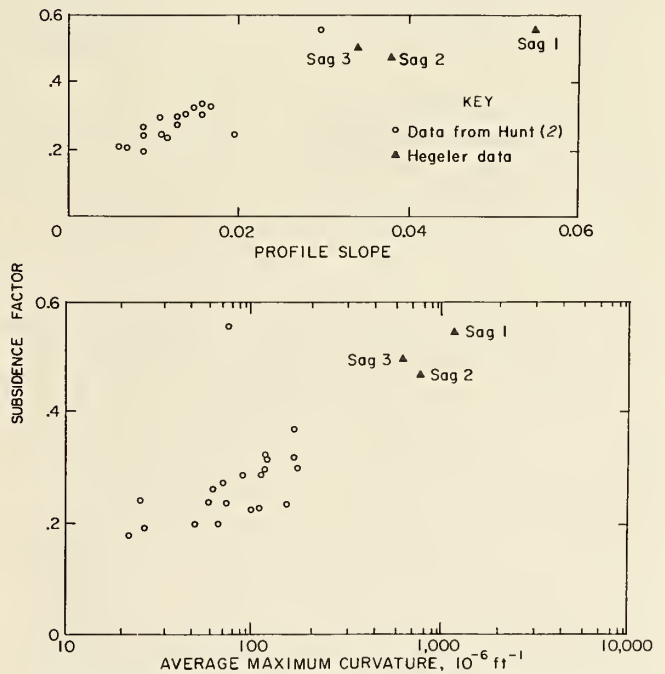
FIGURE 13. - Relationship between the subsidence factor and (A) profile slope and (B) average maximum curvature.

In general, the maximum slopes and curvatures of subsidence sags tend to increase with increasing subsidence factors. These relationships are shown by Hunt (2) for subsidence profiles in Illinois. The sags at the Hegeler site, however, are more severe than those studied by Hunt (fig. 13).

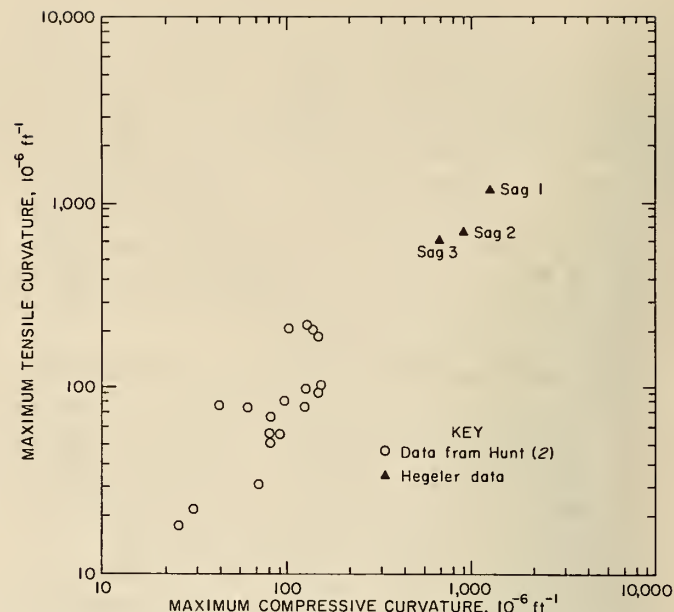
FIGURE 14. - Relationship between maximum tensile curvature and compressive curvature.

Figure 14 shows that maximum tension and compression are almost equal in cases of Illinois mine subsidence above abandoned room-and-pillar mines. However, when compared with data from other Illinois mines, the Hegeler sags are much more severe.

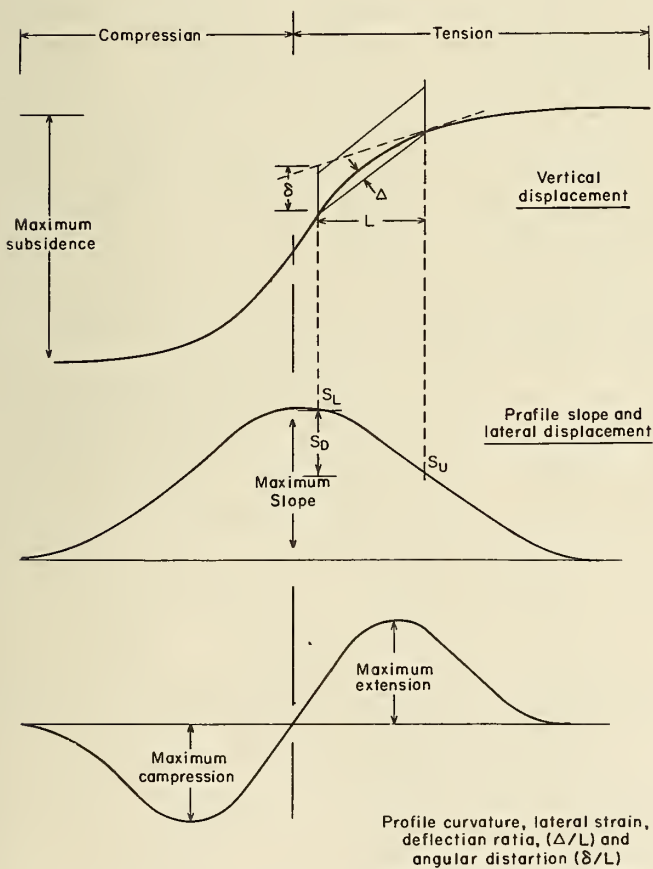
FIGURE 20. - Relationships between subsidence profile characteristics and ground deformations.

ground movements, the structural characteristics and interaction effects, the presence of construction joints, and previous deformation history (12). Subsidence characteristics are usually defined in a two-dimensional profile showing the vertical displacement, slope, and curvature (fig. 20). Compression occurs where the lateral ground displacements decrease in the direction of lateral ground movement, whereas extension exists where ground displacements increase in the direction of lateral movement.

The nature and intensity of structural deformations usually change along the length of the structure because of variations in the ground surface displacements. The induced deformations and rigid body movements can be estimated by parameters that described the subsidence profile along the length of the structure. The profile parameters include the slopes at the lower (S_L) and upper (S_U) ends of the structure, the difference between the lower and upper slopes (S_D), the angular distortion, the deflection ratio, and the curvature (fig. 20).

Lateral ground displacement has the same pattern and is proportional to the profile slope. The magnitude of lateral strain along a section of profile can be related to the section curvature, which is estimated by dividing the difference in slope (S_D) at the ends of the section by the length (L) of the structure. The section curvature is also proportional to the deflection ratio which is used to estimate the bending deformation (fig. 20).

Angular distortion is used to estimate the induced vertical shear strains. It is calculated as the vertical distance between the profile tangent at the lower and upper ends of the structure along the subsidence profile (δ) divided by the length (L) of the structure (fig. 20). Rigid body rotations are not included in the angular distortion parameter. The induced tilt is a function of the profile slope. Induced rigid body horizontal and vertical displacements across the structure are related to the differences in lateral displacement and differential settlement.

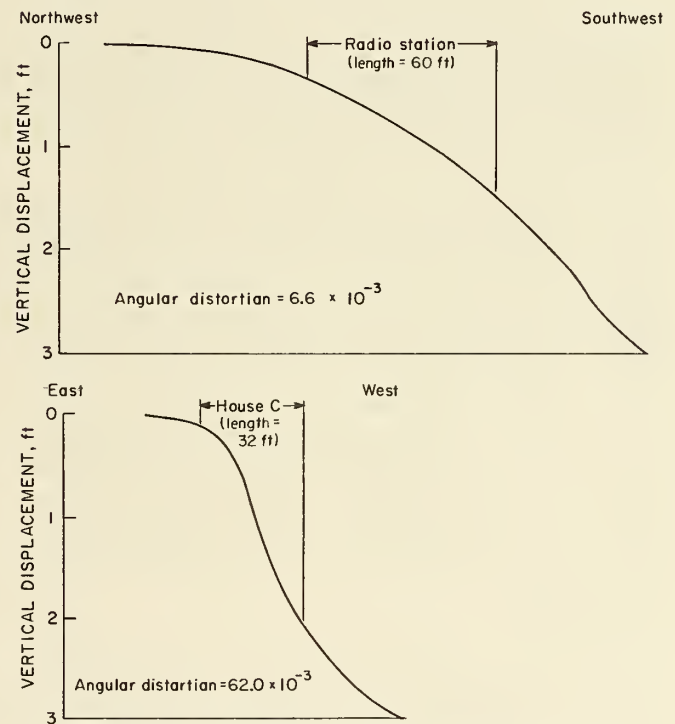
FIGURE 21. - Comparison of subsidence profiles of radio station building and house C. No horizontal scale is indicated because no common origin exists for both structures. However, the length of each structure is given so that a comparison can be made regarding vertical displacement over the length of each structure.

The radio station building and house C were located in the tension zone of the same sag. A comparison of the subsidence profiles along both structures taken parallel to the direction of horizontal ground movement is shown in figure 21. The subsidence profile along house C is much more severe than the profile along the radio station building. For example, the angular distortion along the house is 62.0×10^{-3} compared with 6.6×10^{-3} along the radio station building. Other profile parameters (table 2) also show that house C was subjected to more severe ground movements.
